INVESTIGATION REPORT OF THE FIRE AT STOUFFER'S INN OF WESTCHESTER

Harrison, New York

JAMES R. BELL

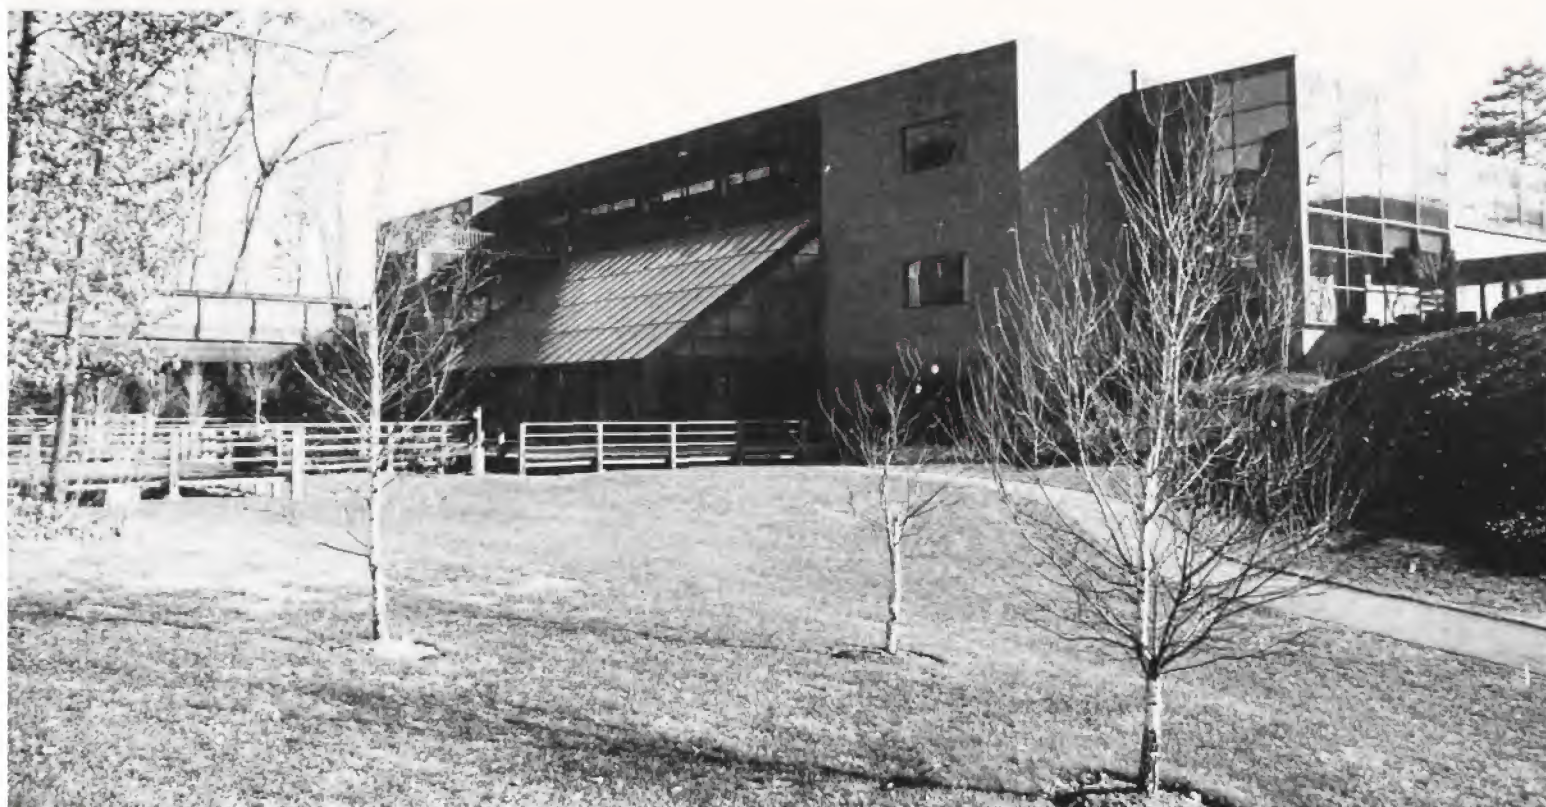
Below: The Conference Center from the southwest. The railings of the promenade deck and windows of the burned-out Common area of the third floor are above the slanted, glassed-in area housing the indoor swimming pool.

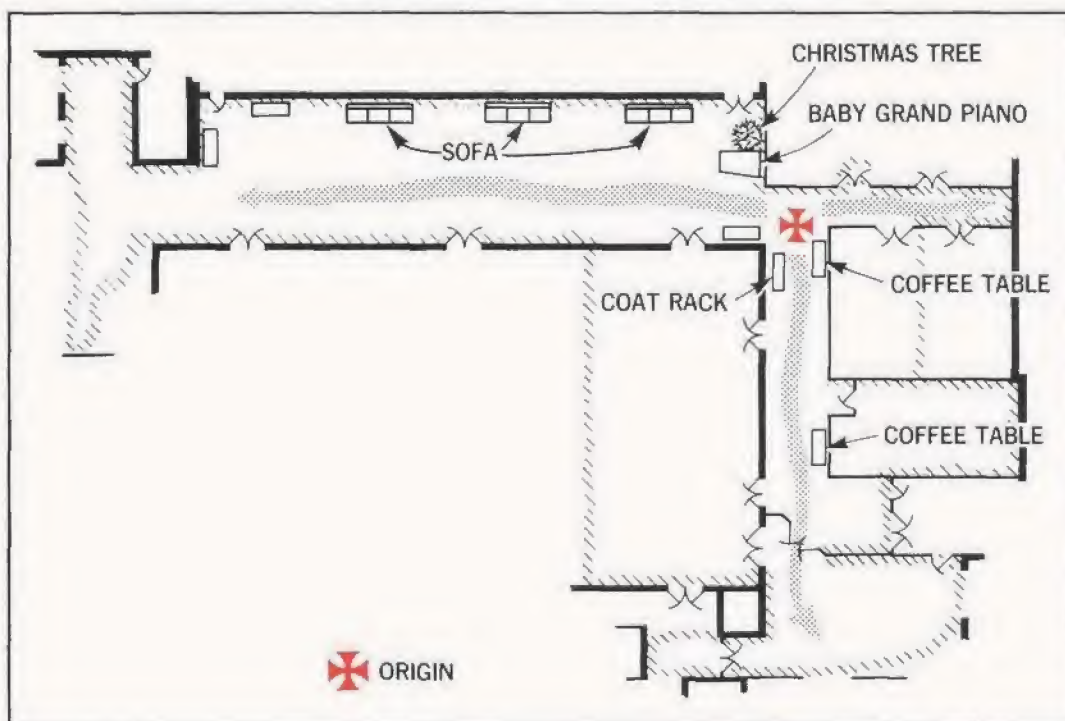
Figure 3. Simplified representation of contents in North Corridor and The Common, plus smoke and flame spread (indicated by dotted pattern). Drawing not to scale.

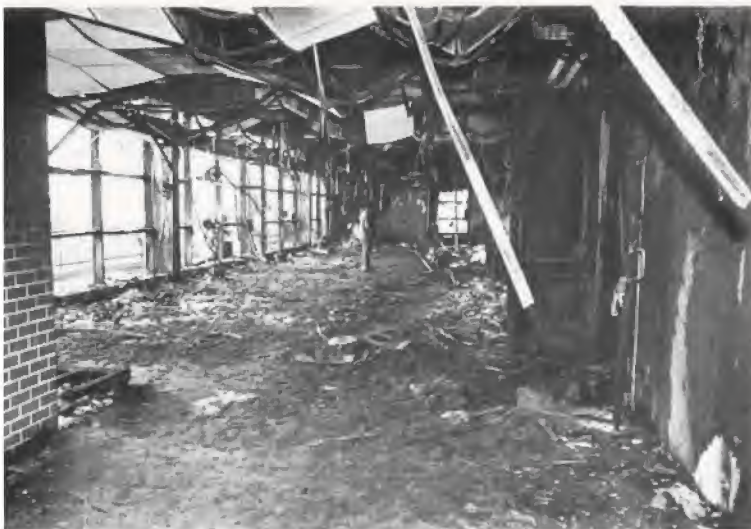
The Common, looking north toward the area of fire origin. Exit access door to the Wilson Room in the Grand Ballroom is at right. NFPA

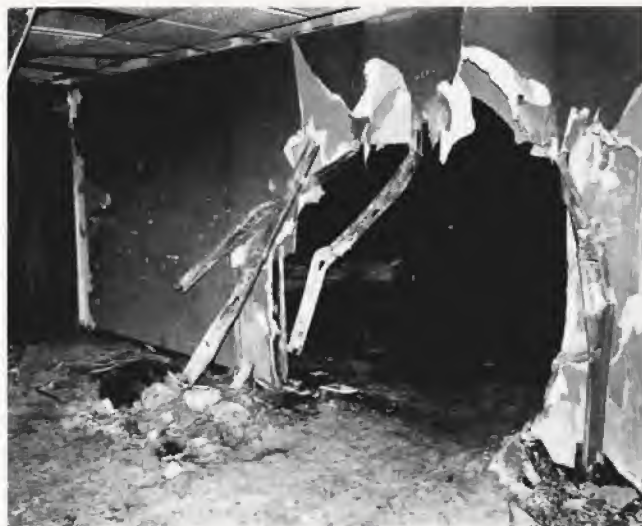
The wall between the Haight Room and the north exit corridor. Rescuers breached the wall in an effort to save the occupants. NFPA

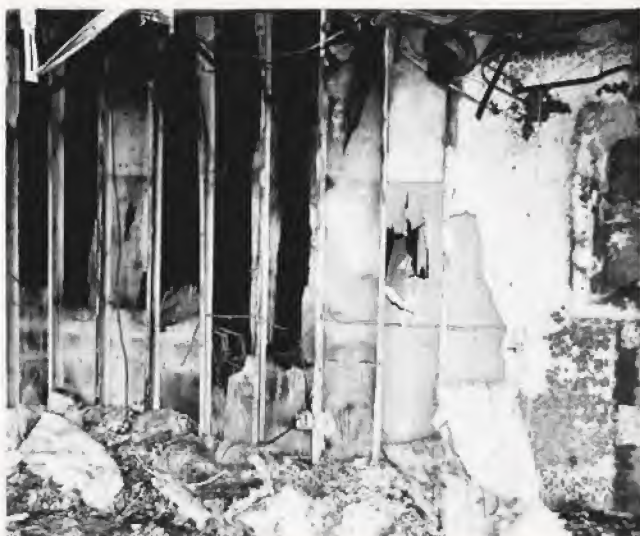
Corridor wall construction between Disbrow Room A and The Common, viewed from The Common. NFPA

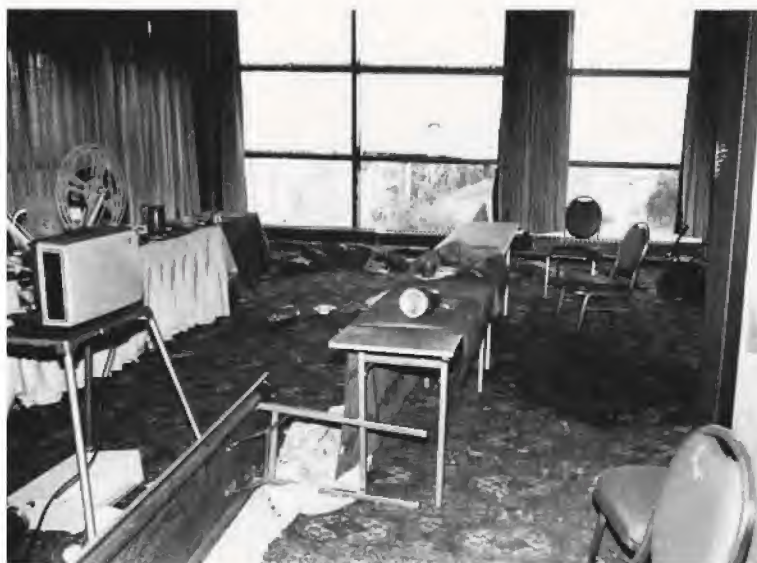
The Harrison Room, looking toward the north. Occupants of the room broke out the glass with a folding table and jumped to the ground 15 feet below. NFPA

With heavy black smoke filtering through cracks in both sets of doors, occupants were forced to break tempered glass window lites (panels). They made several attempts to break the glass, using chairs and a folding table. The occupants were finally able to break the glass on the north wall of the room by using a table as a battering ram. They jumped approximately 15 feet to rocky, uneven grade below, sustaining laceration and fracture injuries.

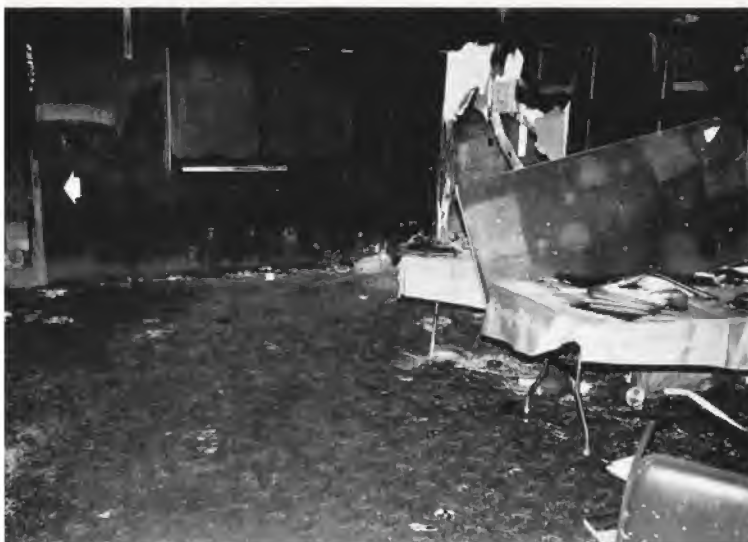
Eleven occupants of the Haight Room had remained in the room. Six of these occupants had apparently taken refuge from fire conditions that were entering the room

The Haight Room, where 12 executives were trapped when the one doorway into the corridor was blocked by fire conditions. Six of the occupants were found in the closet at left (see arrow). NFPA

by taking refuge in a storage closet. Five of the fatalities were found in the meeting-room area.

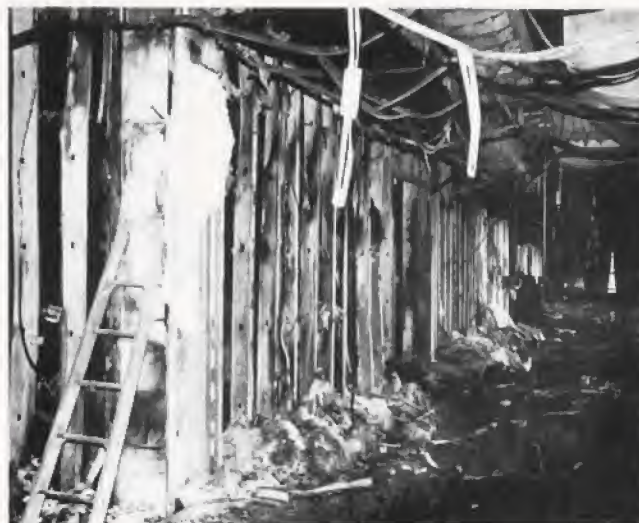
The Common, looking south from the area of fire origin. Exit access doorway from Disbrow Room A to The Common is in the center. NFPA

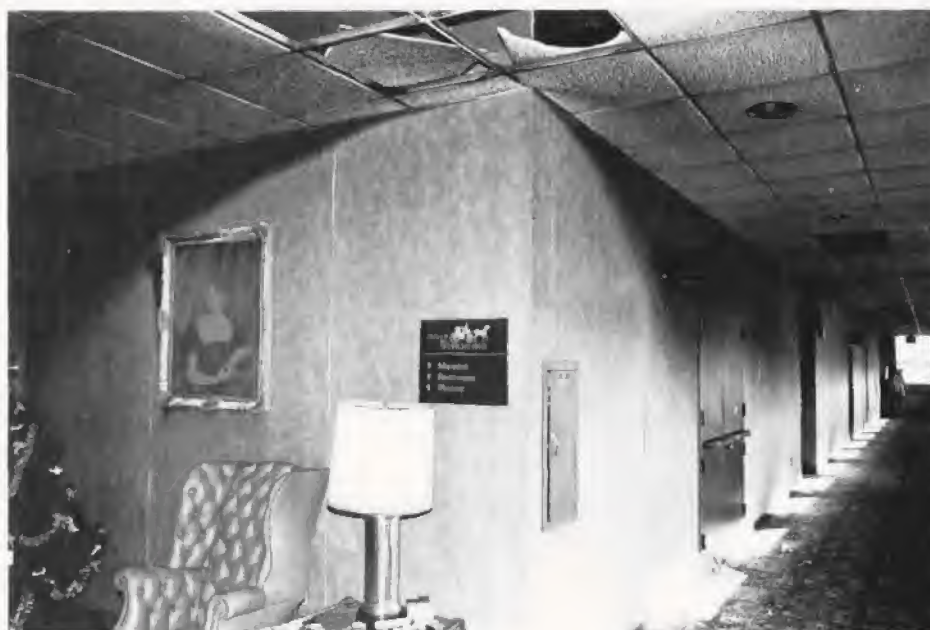
combustible furnishings, wall covering, carpeting, and decorations in The Common.⁸ Although furnishings in The Common were "sparse," there was sufficient fuel loading to allow additional burning in that area. The extension of burning beyond the south end of The Common was limited by the domestic sprinkler protection.

Wall area at the south end of The Common at the intersection with the South Corridor seen at right. Pattern and effect of one of the four domestically fed sprinkler heads (top) is clearly shown. NFPA
